Manhole Inspection Summary

Manhole # S53E__025MH

Insp Date: **12/23/08 10:14 AM**

Location Address: **rear 148 s east av**

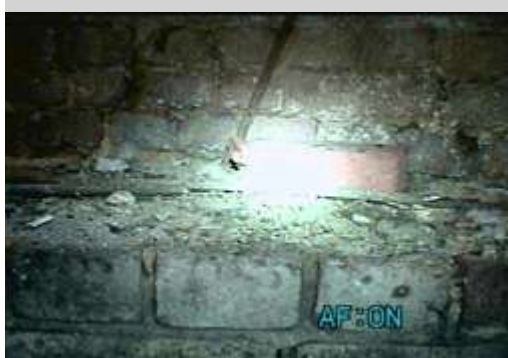
Miscellaneous

Condition: ☒ Sound ☐ Cracked ☐ Root Intrusion ☐ Deteriorated ☐ Leaks ☐ Debris

bench debris

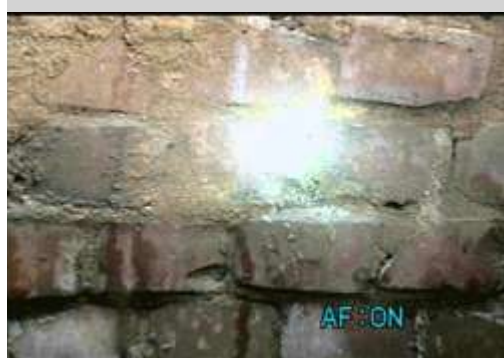
Defect 5

Infiltration: ☐ None ☒ **Joint** ☐ Cracks ☐ Mortar ☐ Roots ☐ Wall

chimney infiltration at corbel joint

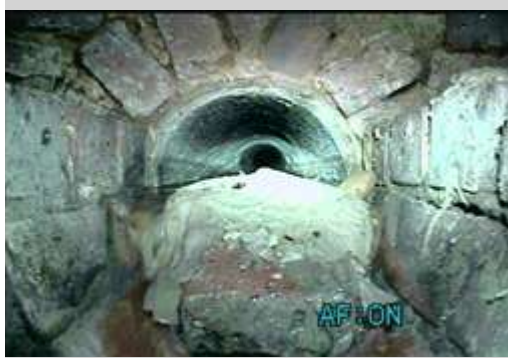
Defect 4

Condition: ☐ Sound ☐ Cracked ☐ Root Intrusion ☐ Deteriorated ☐ Leaks ☒ **Debris**

channel debris

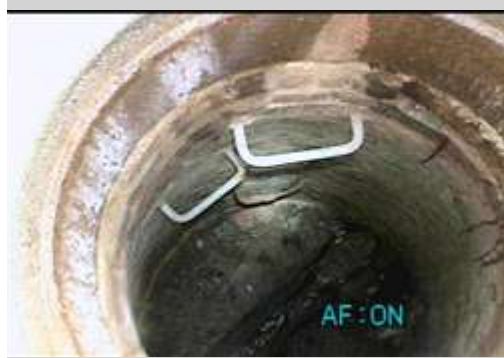
Defect 2

Steps Count: **4** Missing: **1** ☒ **Corroded**

steps corroded, missing 1

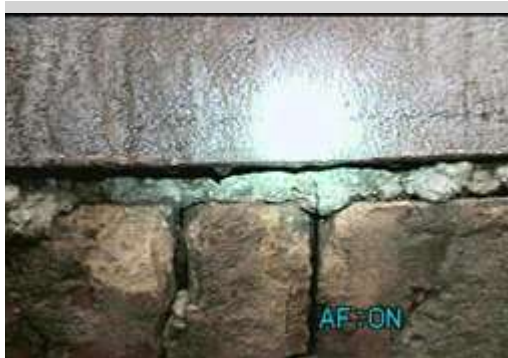
Defect 1

Condition: ☐ Sound ☒ **Cracked** ☐ Root Intrusion ☒ **Loose Brick** ☒ **Deteriorated**

chimney cracked loose deteriorated bricks
with infiltration
